UNDERWATER BRIDGE INSPECTION REPORT

STRUCTURE NO. 93477

CR 71

CROSS RIVER

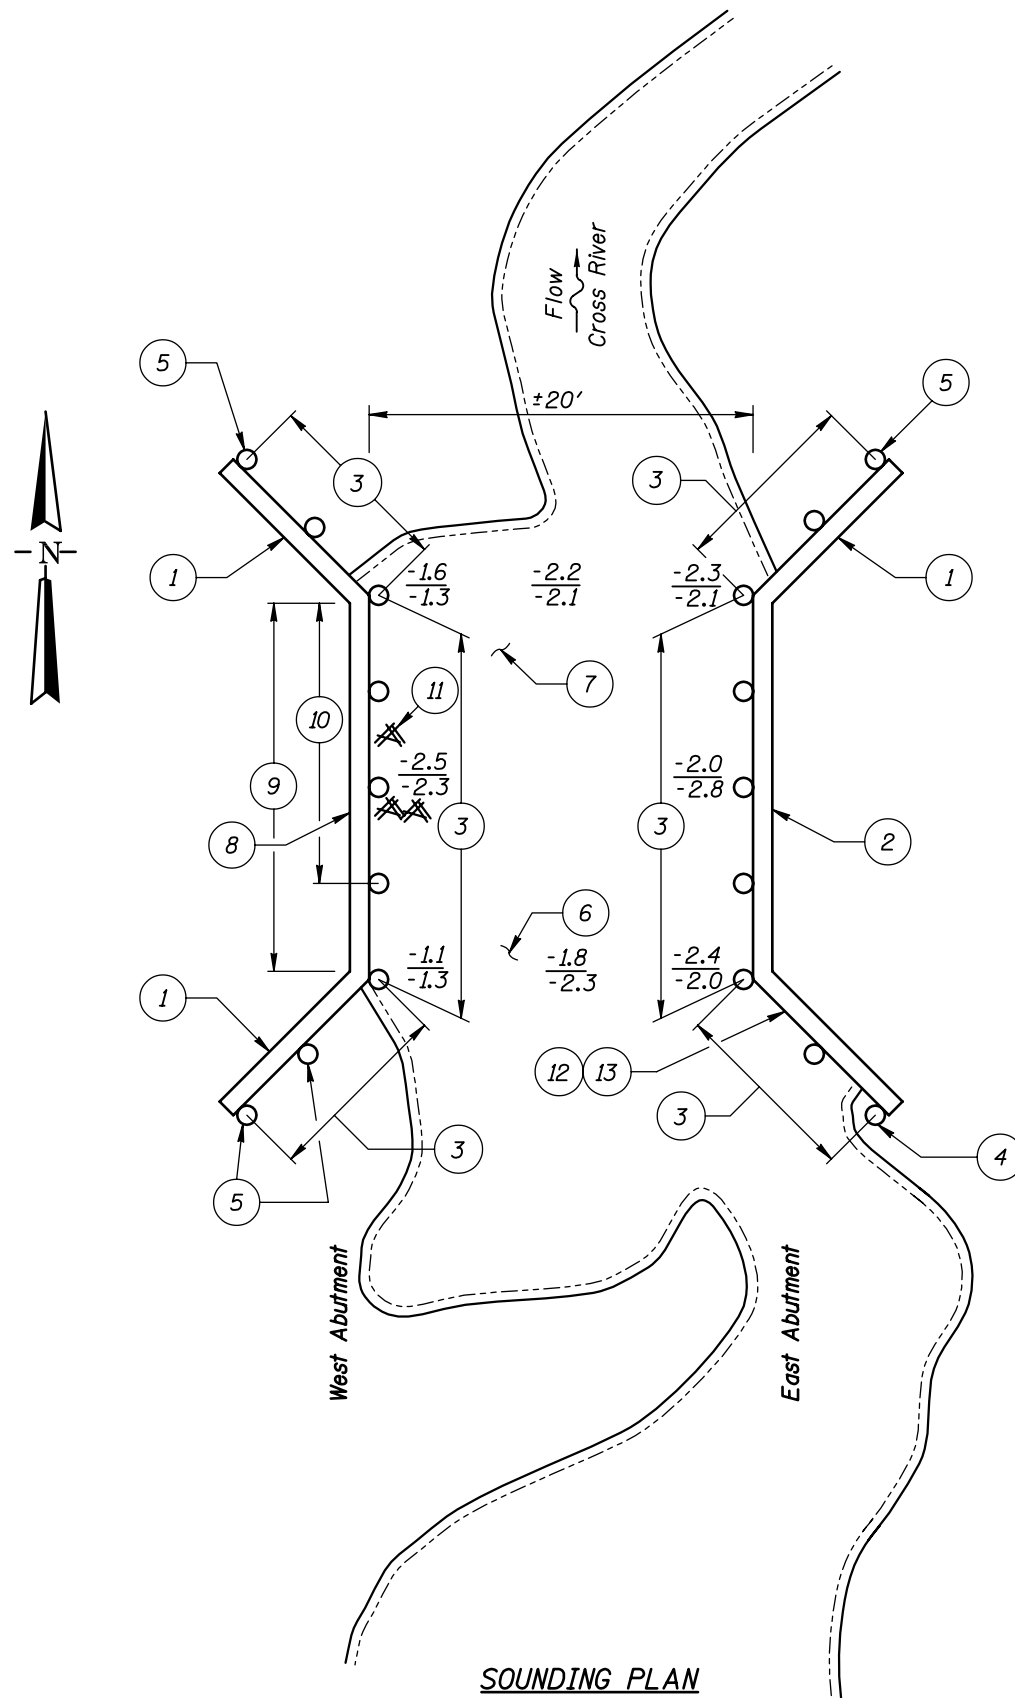
INSPECTION AND SOUNDING PLAN

- 1 Top 2 to 3 feet of wingwall was failing and shifted backward with displaced planking.
- 2 Abutment cap was observed to be rotating backward (away from channel), and the upper 3 feet of the backwall is also moving backwards approximately 6 to 9 inches. Cap is only bearing on 10 to 25 percent of the top of each pile.

- 3 Random checking and cracking up to 1/4 inch wide was observed on all piles above the waterline.
- 4 Pile is deteriorated over the top 3 feet, with up to 75 percent loss of section.

- 5 Pile is deteriorated over the top 3 feet, with up to 50 percent loss of section.
- 6 The channel bottom consisted of sandy gravel with 6 inches of probe rod penetration.

- 7 Channel bottom consisted of silty sand of up to 1 foot of probe rod penetration.
- 8 The upper 3 feet of the backwall is moving 3 to 4 inches backwards, away from the channel, and the cap is bearing on 50 percent of the top of each pile.

- 9 Random 1/2 to 1 inch differential movement between the backwall planking was observed at the West Abutment.
- 10 A 1 inch wide gap with 1 inch of penetration and fill escaping was observed, and was located approximately 3 inches below the waterline.

- 11 Timber drift with branches up to 6 inches in diameter was observed at the West Abutment.
- 12 At 2-1/2 feet above the waterline the planking was spliced outward with 1-1/2 inch wide gap between the planking. A 1 foot deep void was located behind the gap and extended from the gap to the mudline.

- 13 A 2 feet long by 6 inch high area of undermining was located below the 1-1/2 inch wide gap at the mudline.

- (A) Repair measures should be implemented to restore pile bearing and stabilize the backwall planking and pile cap at both abutments.
- (B) Reinspect the submerged substructure units at the normal maximum recommended (NBIS) interval of five (5) years.

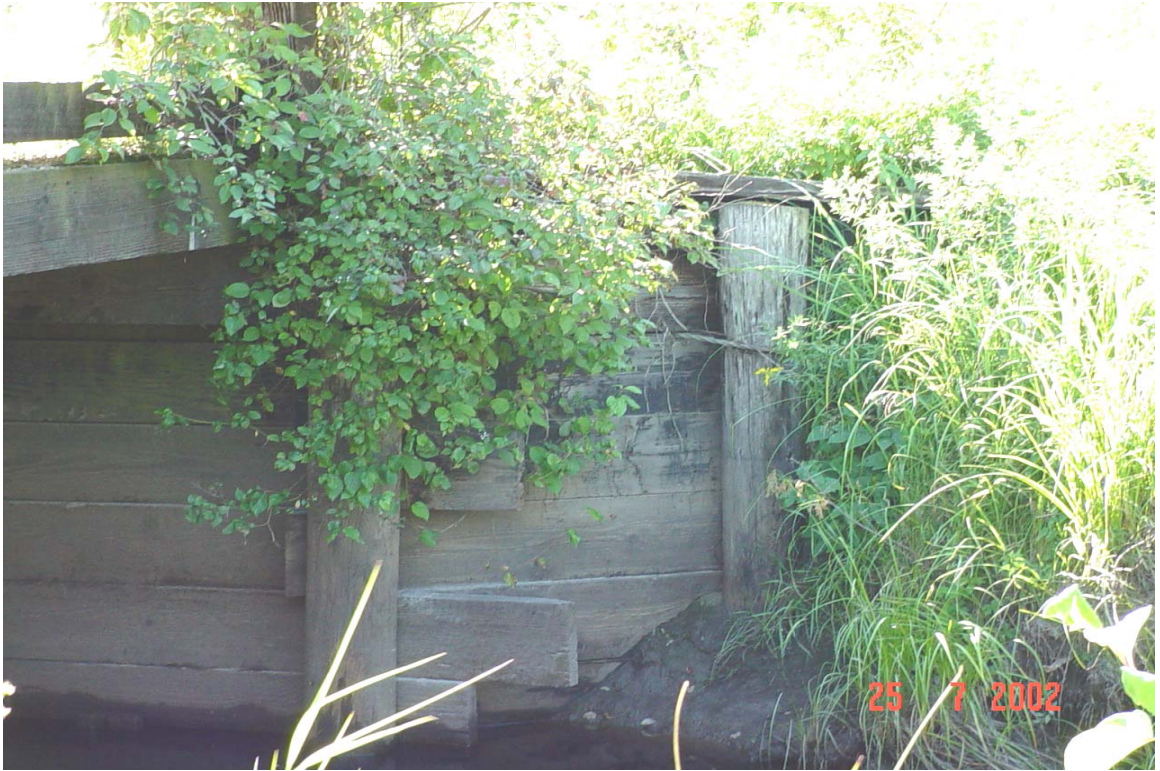
- (A) The wingwall planking at the East and West Abutments was found to be failing and shifted backward over the upper 3 feet of the wall. This condition appears related to erosion of material behind the wingwalls due to roadway runoff. Random wingwall piles exhibited a loss of section ranging from 50 to 75 percent in the upper 3 feet of the pile.
- (B) The pile cap at both abutments was rotating backward and only bearing on between 10 and 25 percent of the top of each pile.
- (C) Random checking and splitting, up to 1/4 inch wide, was observed on all of the piles.

Photograph 3. View of North Wingwall on the West Abutment, Looking Southwest.

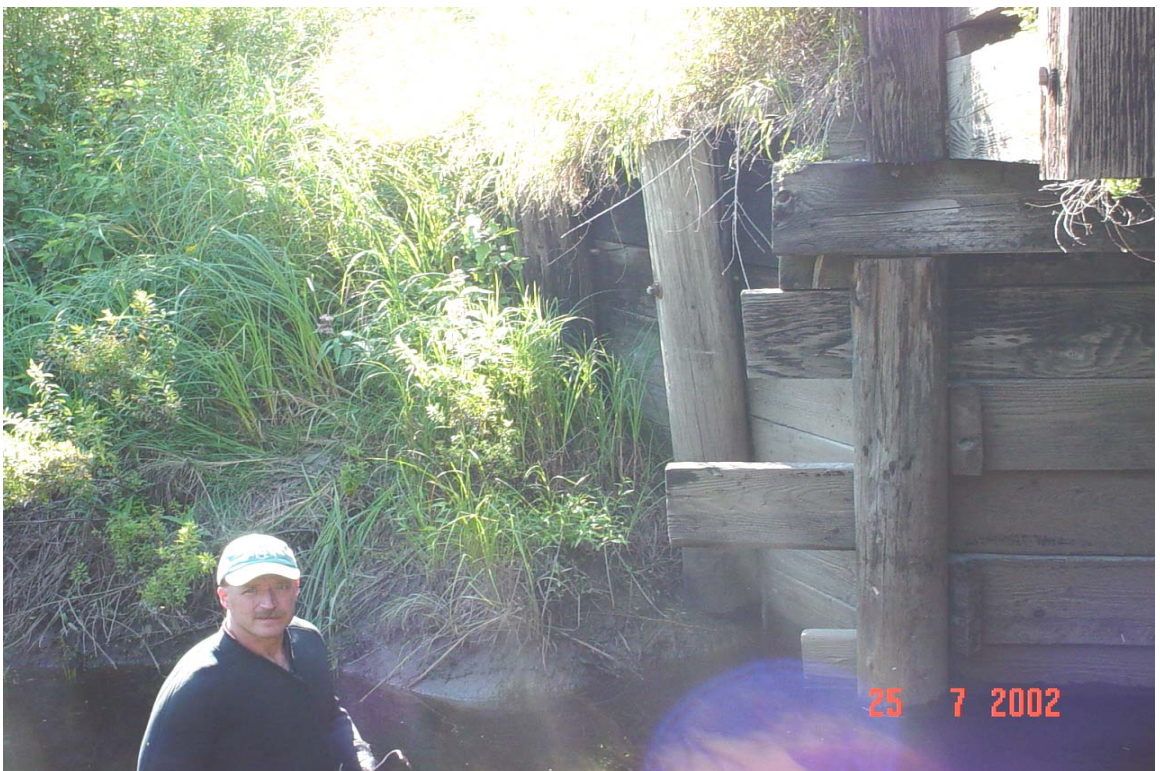
Photograph 4. View of South Wingwall on the West Abutment, Looking Southwest.

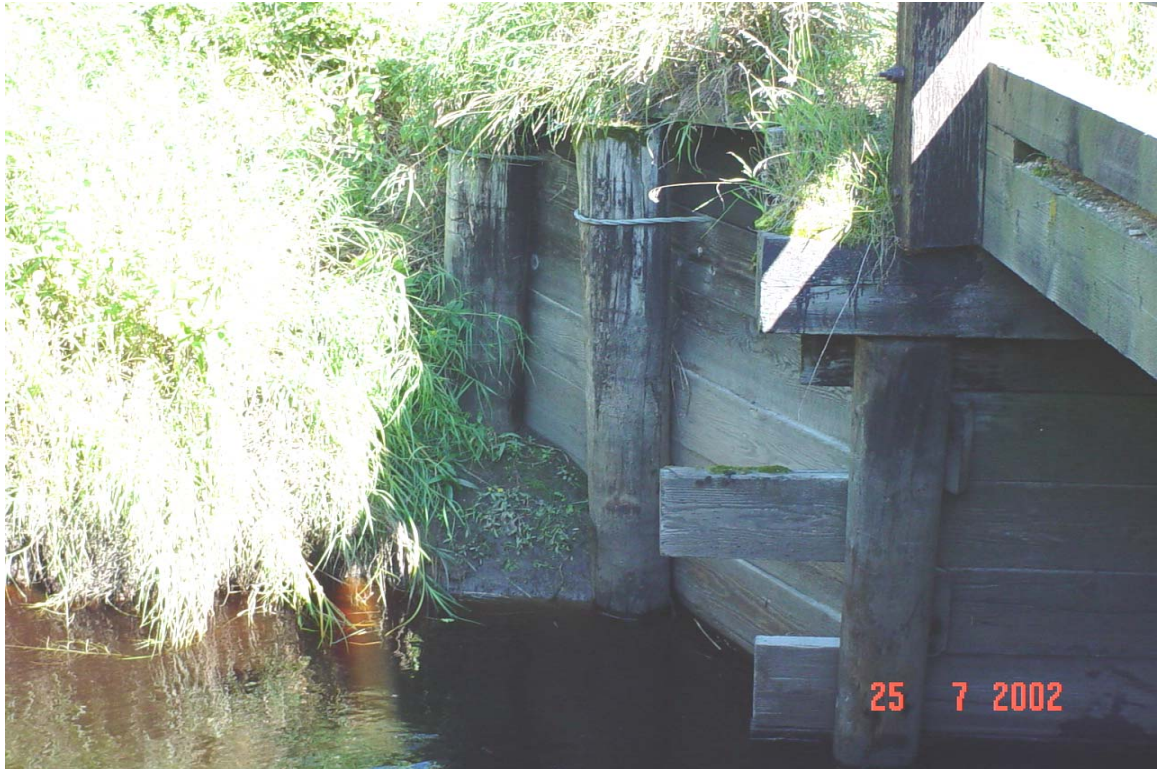
Photograph 5. View of North Wingwall on the East Abutment, Looking East.

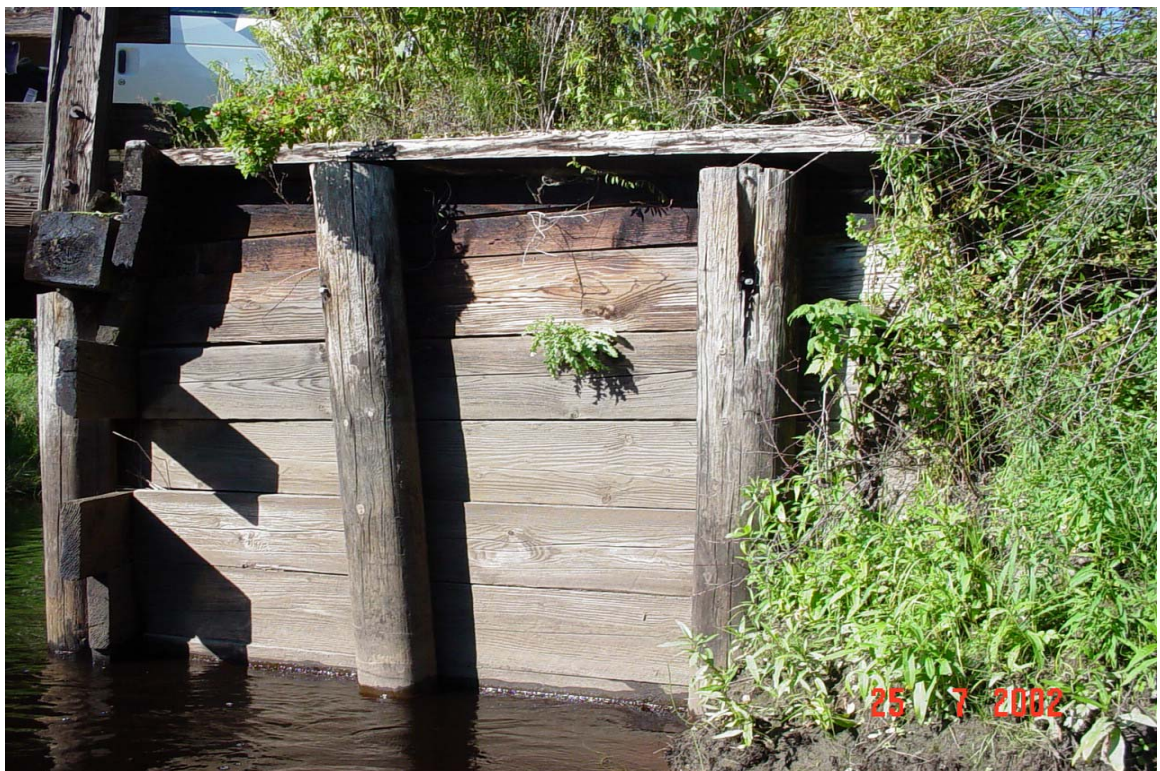
Photograph 6. View of South Wingwall on the East Abutment, Looking Northeast.

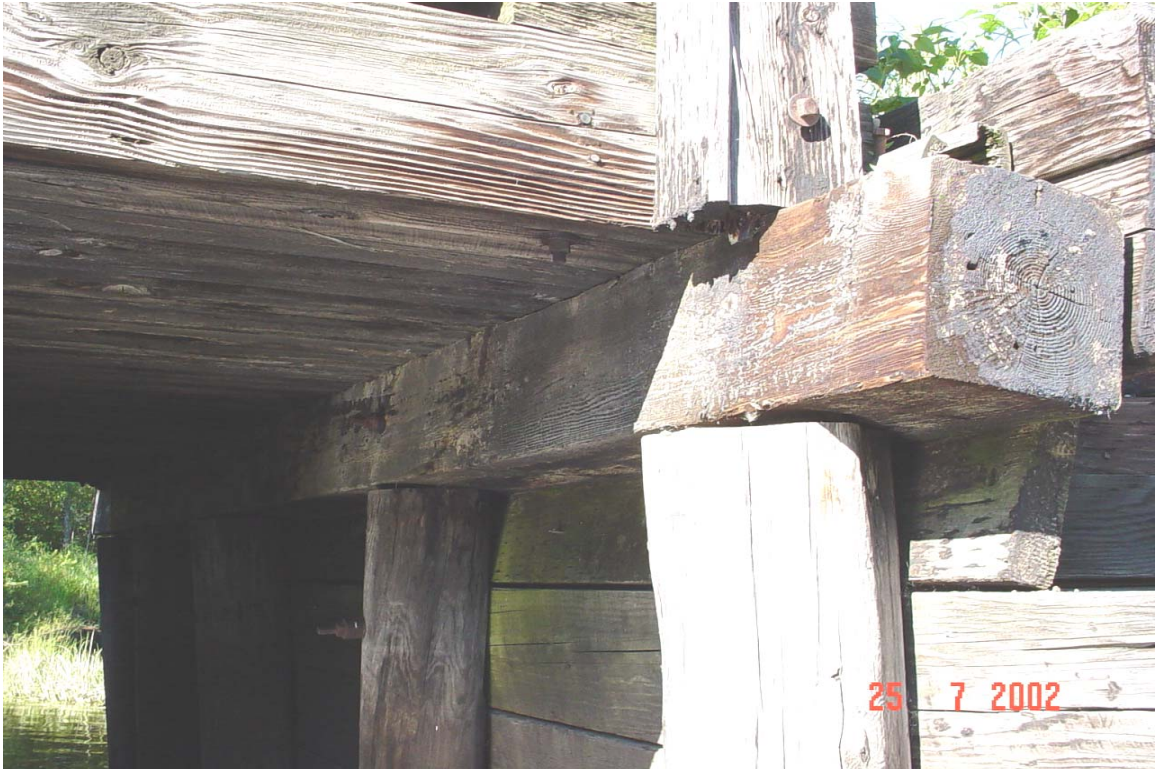
Photograph 7. View of the Top of the East Abutment, Looking Northeast.

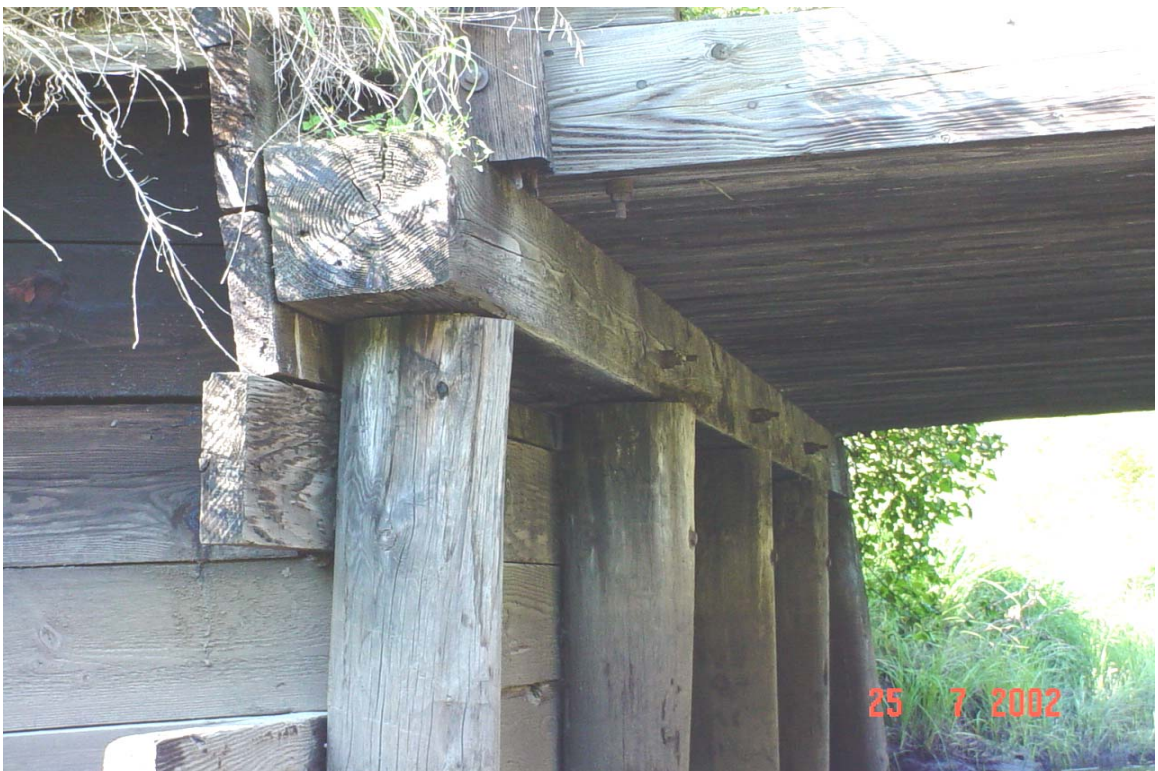
Photograph 8. View of the Top of the West Abutment, Looking North.

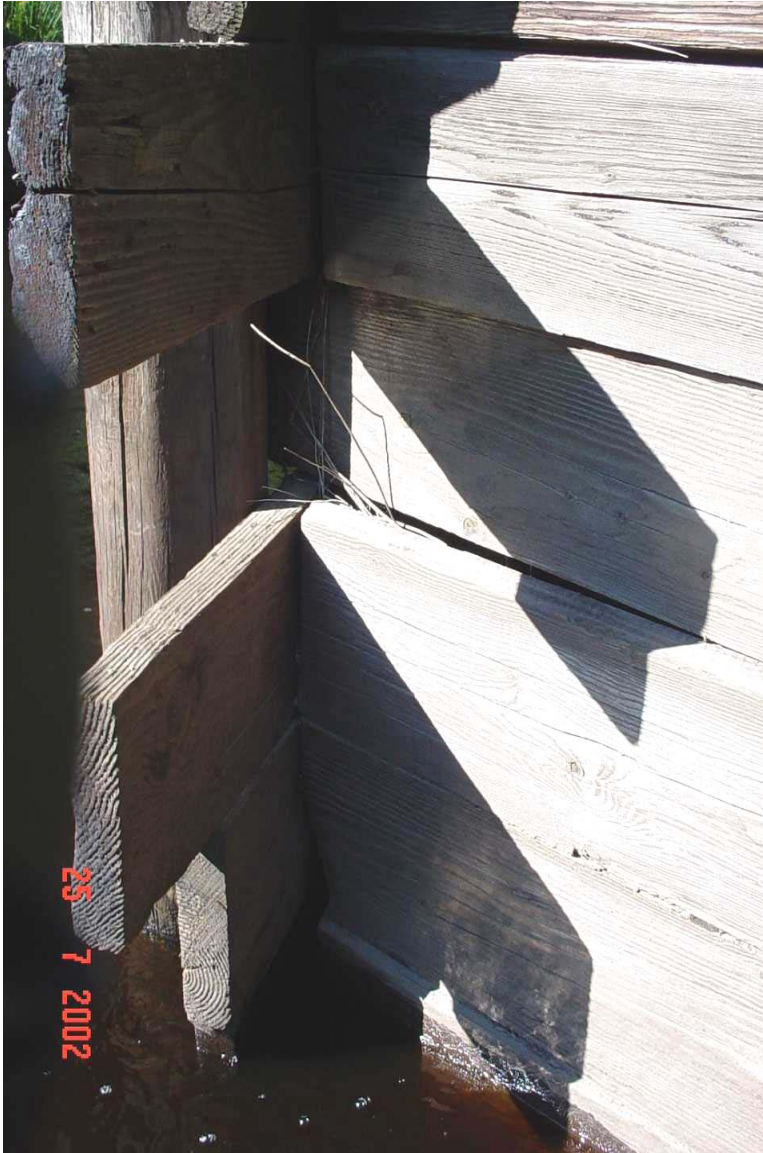
Photograph 9. View of Gap in the South Wingwall on the East Abutment, Looking Northwest.
